Efflorescence Control in Grout with MetaMax[®] EF

Evaluation of MetaMax[®] EF in Grout Formulation

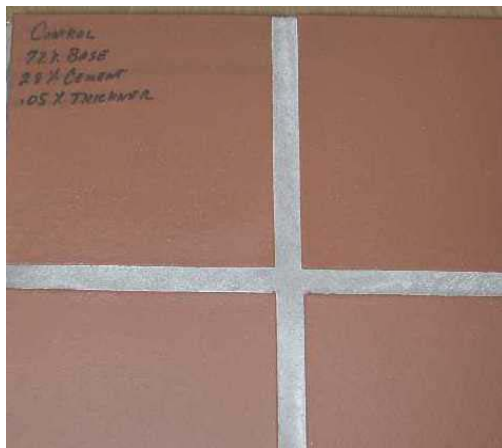
Control at 96 hours, Severe efflorescence

Control Mixture

96 hours: efflorescence had completely covered the grout lines between the tiles.

7 days: little change from 96 hours, entire grout line appears to be white with efflorescence.

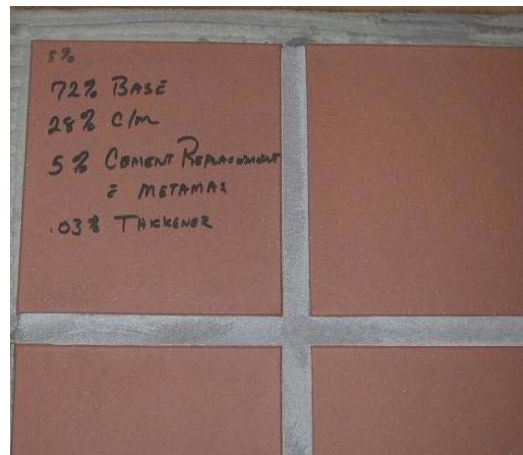
5% MetaMax[®] EF @96 hours, Slight efflorescence

5% Cementitious Mixture

96 hours: color variations continue, slightly more efflorescence noted in some areas along the edges of tiles.

7 Days: color variation continues, slight efflorescence is now noted in center of grout line, compared to the control there is a significant reduction of efflorescence.

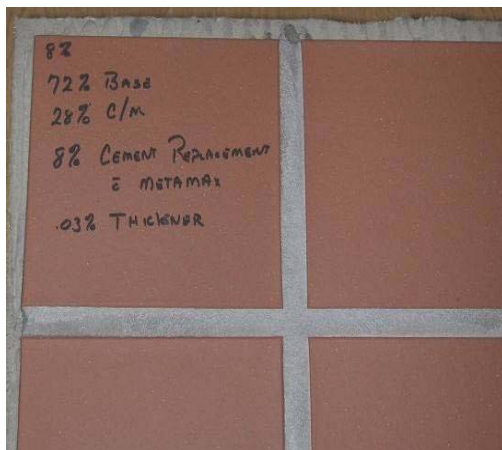
8% MetaMax[®] EF @96 hours, Very slight efflorescence

8% cementitious Mixture

96 hours: curing continues, no increases in the amount of efflorescence

7 days: just slightly more efflorescence noted. Compared to the 5% cementitious material there is a again a reduction in efflorescence.

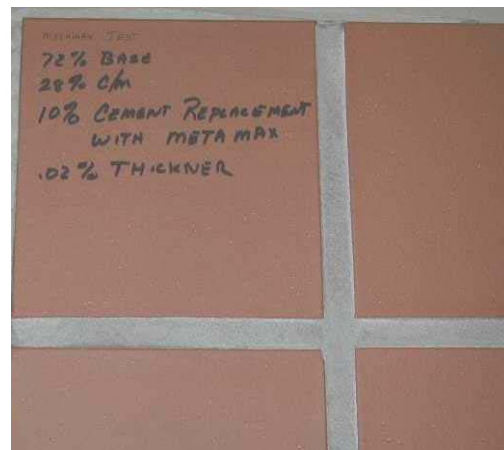
10% MetaMax[®] EF @96 hours, None to Very slight efflorescence

10% Cementitious Mixture

96 hours: curing continues, very slight amount of efflorescence noted just along the edge of some tiles.

7 days: no increase in efflorescence noted
